Structural Behaviour of Masonry Arches on Moving Supports: from On-site Observation to Experimental and Numerical Analysis

DOCTOR OF PHILOSOPHY

*Civil, Chemical and Environmental Engineering
University of Genoa, Genoa, Italy*

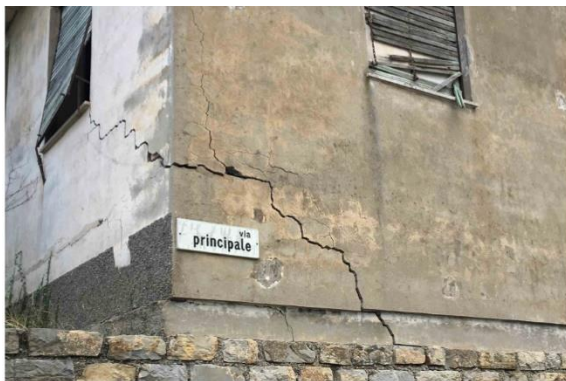
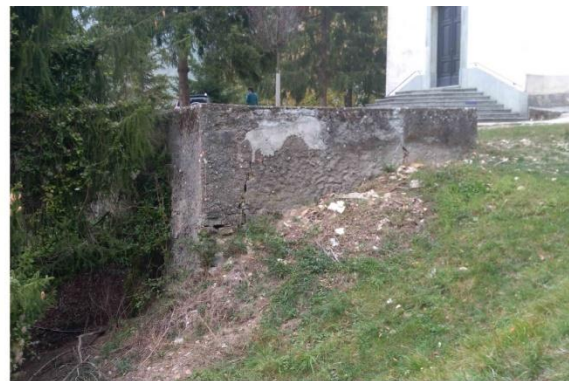
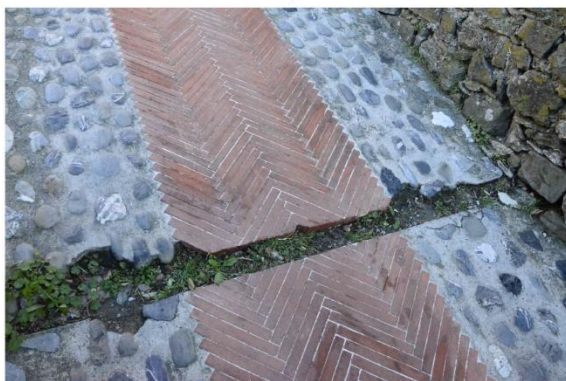
Lastly, as shown in Figure 2-5, for each church an inspection of the surroundings was performed in order to detect any potential evidence of ground movements: (i) cracks and distortions in neighbouring buildings (Figure 2-5a), (ii) cracks in the retaining wall of the embankment on which the church parvis is resting (Figure 2-5b), (iii) cracks in road surfaces (Figure 2-5c), (iv) inclined street lights or trees (Figure 2-5d).

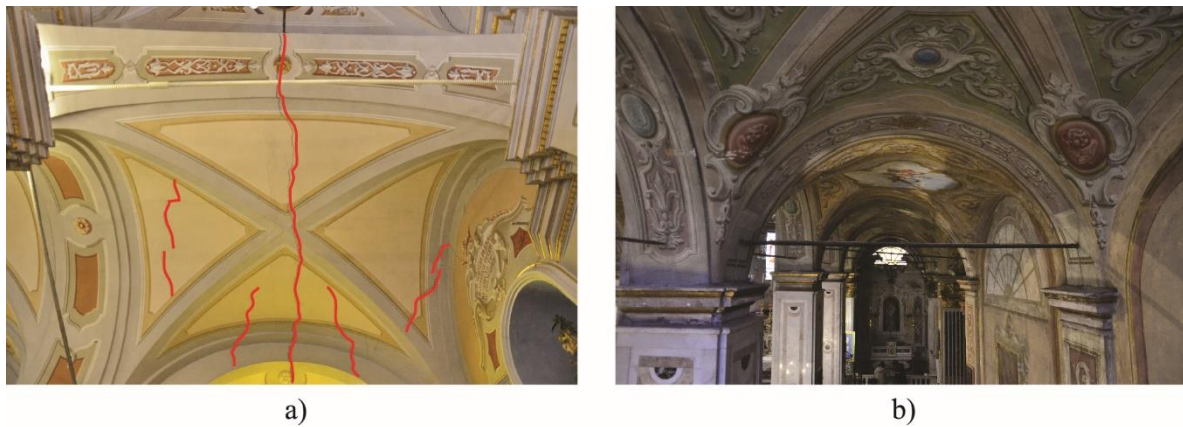
Figure 2-9 Damage in arches and vaults: a) widespread cracking (CH_32), b) large deformations (CH_13).

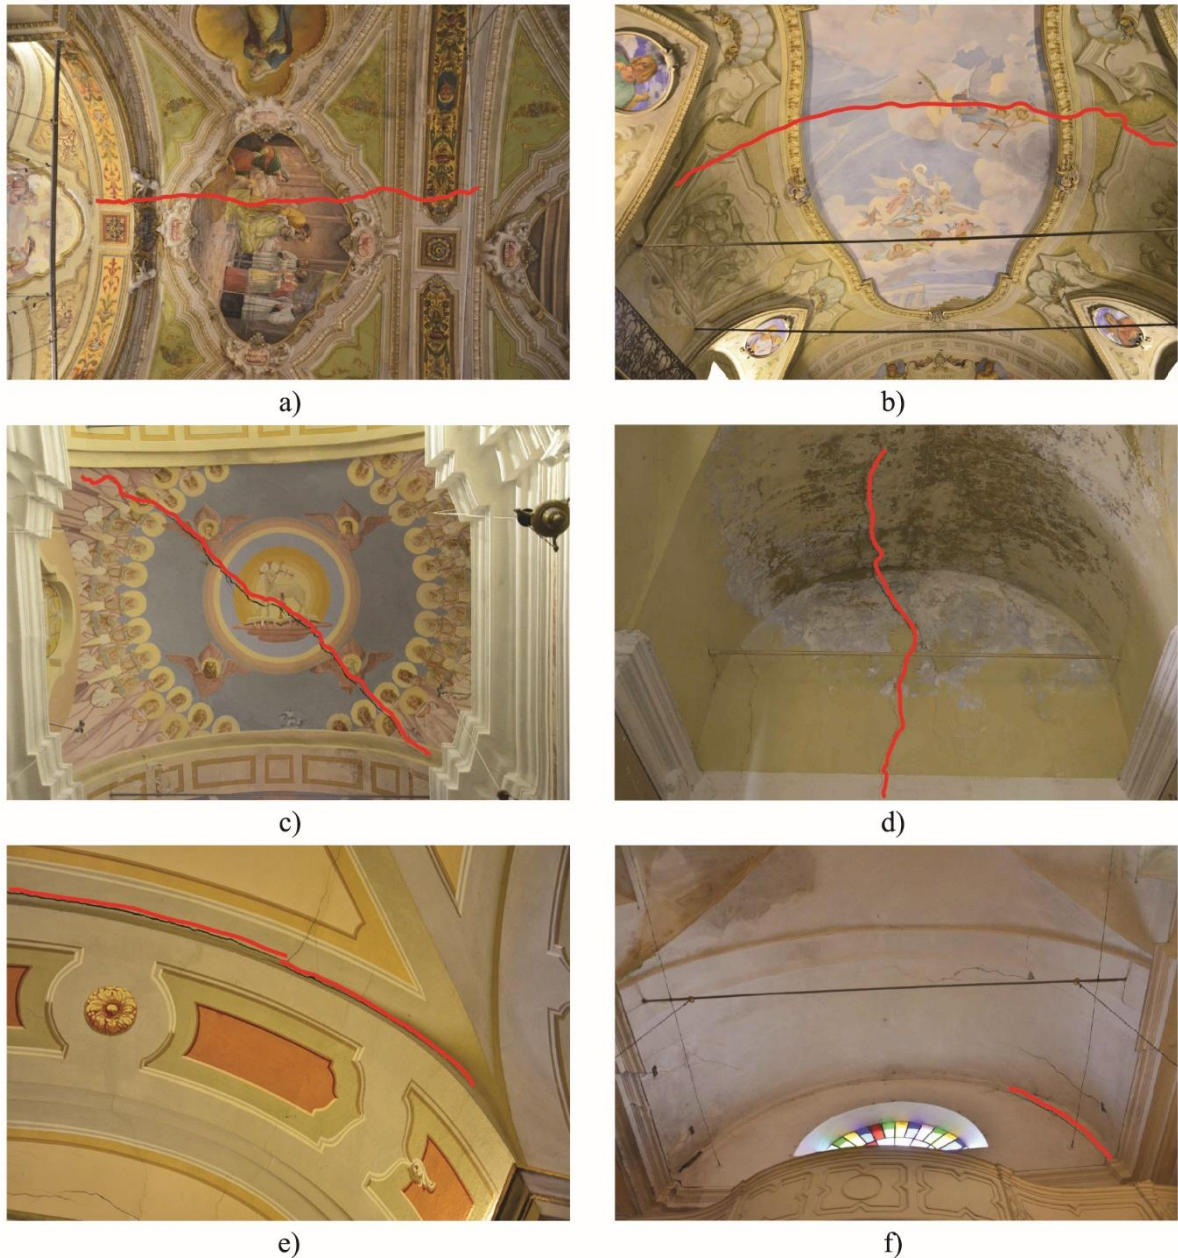
Figure 2-18 Crack patterns of masonry vaults: a) longitudinal cracks (CH_28), b) transverse cracks (CH_17), c) diagonal cracks (CH_4), d) cracks continuous between vault and supporting wall (CH_22), e) cracks at the intersection between arches and vaults (CH_32), f) cracks at the connection between vault and supporting wall (CH_2).

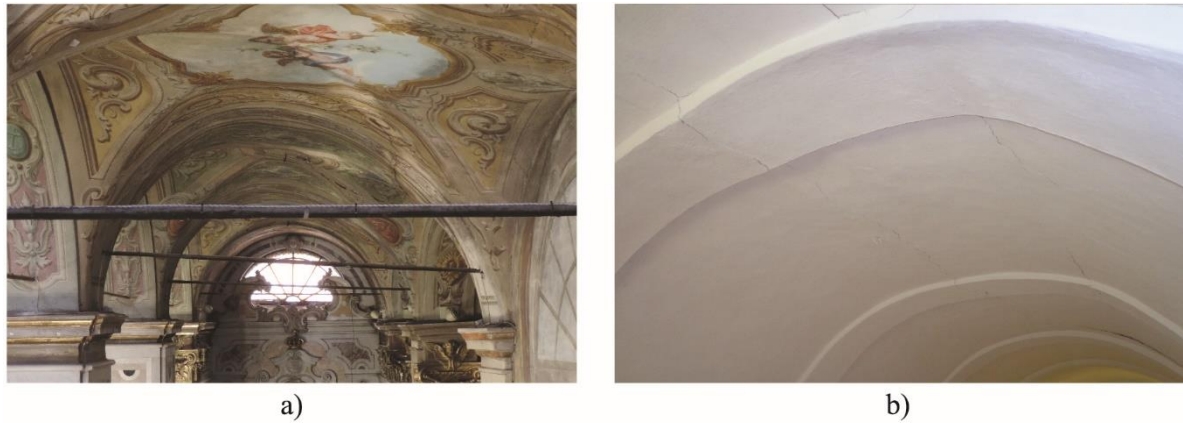
Figure 2-21 Large deformations observed in cross vaults (a) and barrel vaults (b).
